NATIONAL BUREAU OF STANDARDS REPORT

**STRUCTURAL
PERFORMANCE
TEST:**

neal mitchell
housing system

Interim Report

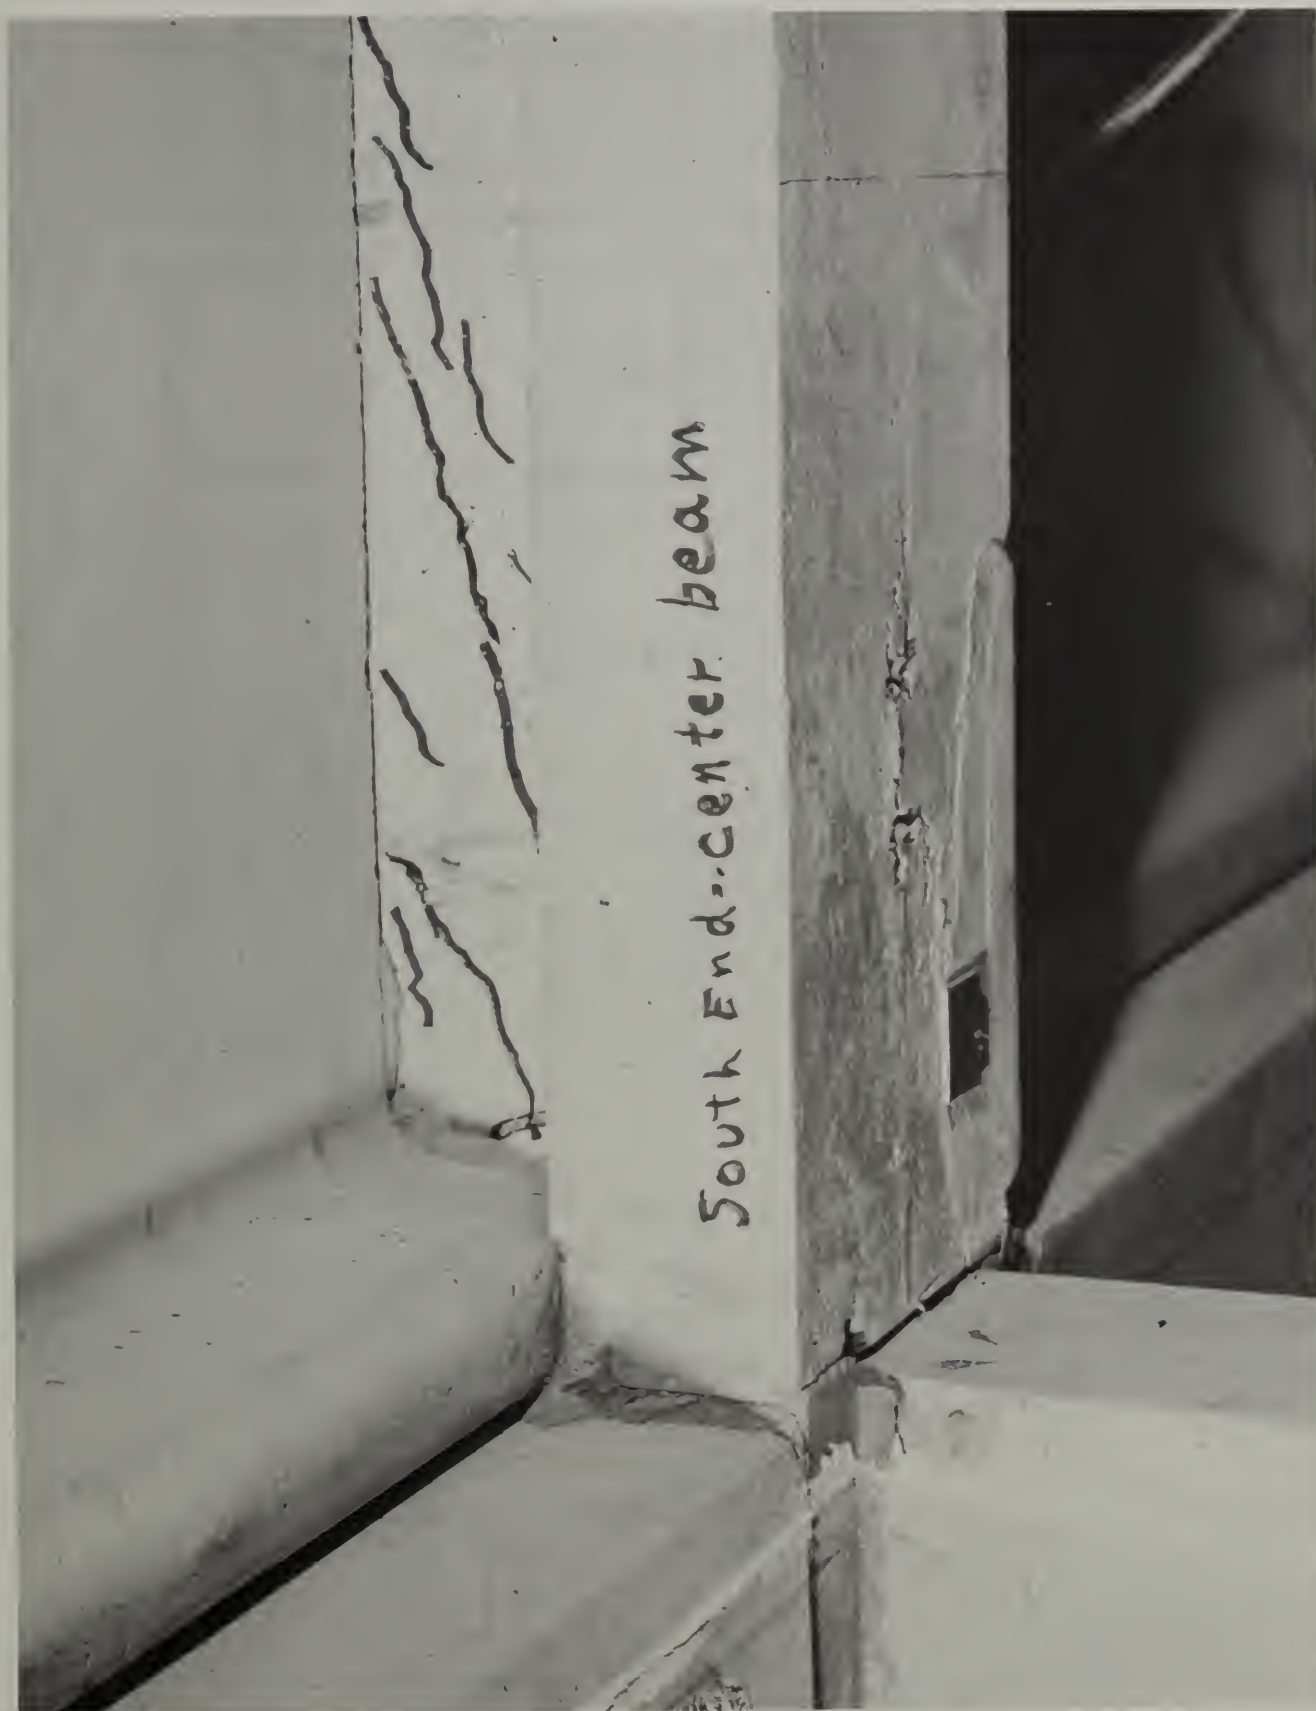
Fig. 9.23 Diagonal tension cracking at $W=270$ PST
(test No. 16)

The break which is evidenced at 270 psf is more marked. At this load, diagonal tension cracks were observed close to the beam supports (Fig. 9.23). Since there are stirrups in the beam (Fig. 5.6) and since the curve shows that the structure was capable of carrying substantial additional load, this point may represent a transfer of shear stresses to the stirrups. The structure was subsequently loaded to 370 psf ($1D + 8.4L$) without additional signs of distress.

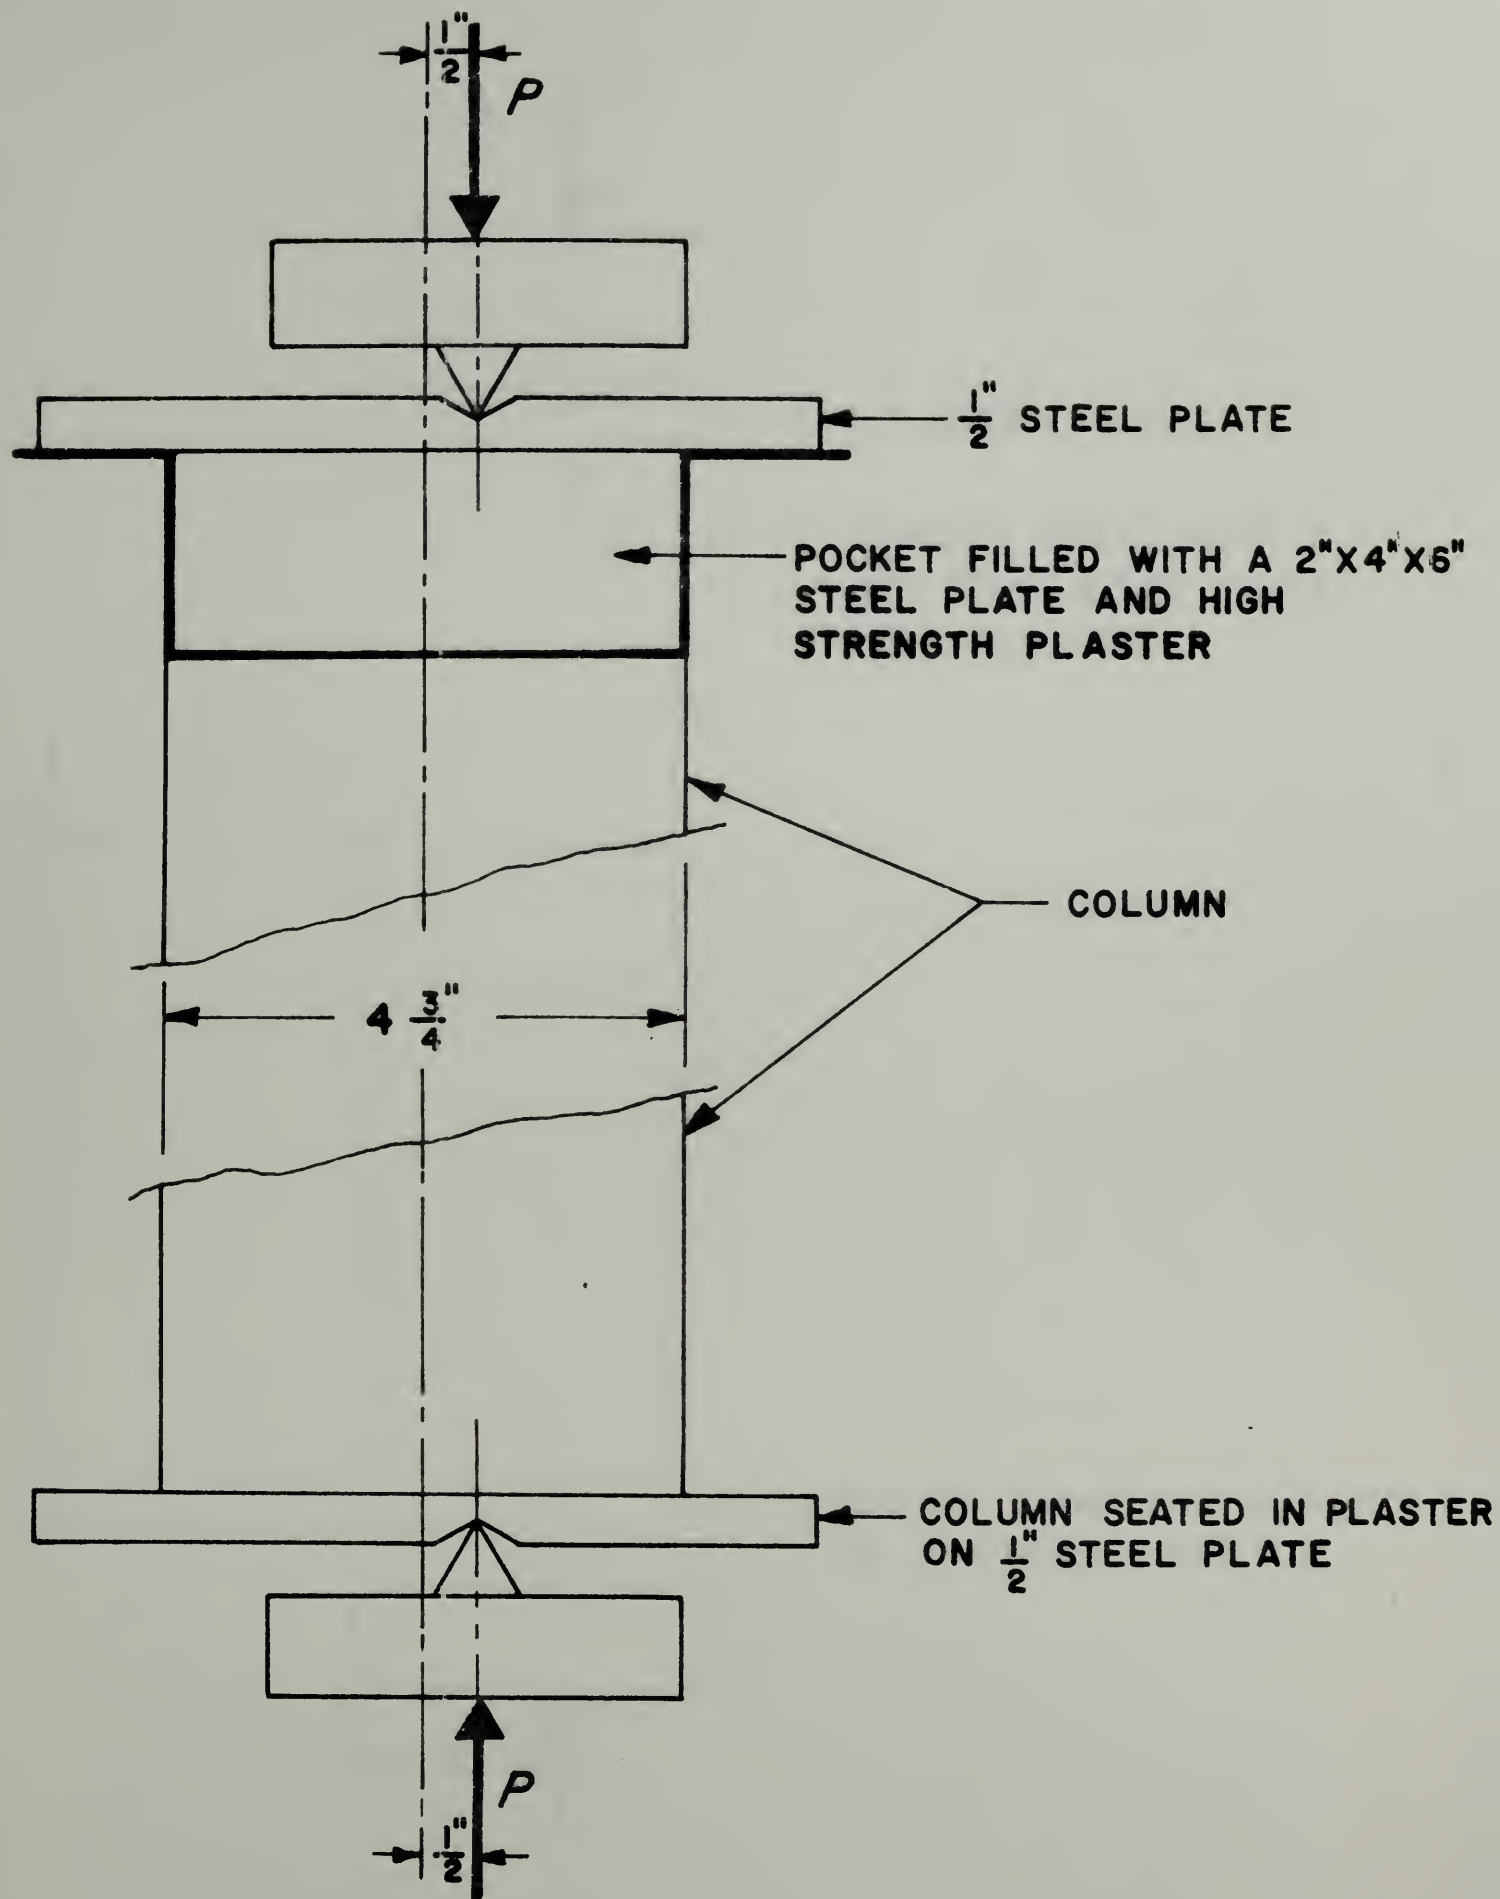
FIG. 10.1 TEST METHOD FOR COLUMN TESTS (Minor Axis)

The loads were applied continuously until failure through a knife-edge loading plate (Figs. 10.1 and 10.2) by a 600 kip hydraulic testing machine at a rate of 8 kips per minute.
